CT-20

INVENTORY FORM FOR STATE HISTORIC SITES SURVEY

St. Edmonds Church and Graveyard

Ponds Wood Road (Dalrymple Road)

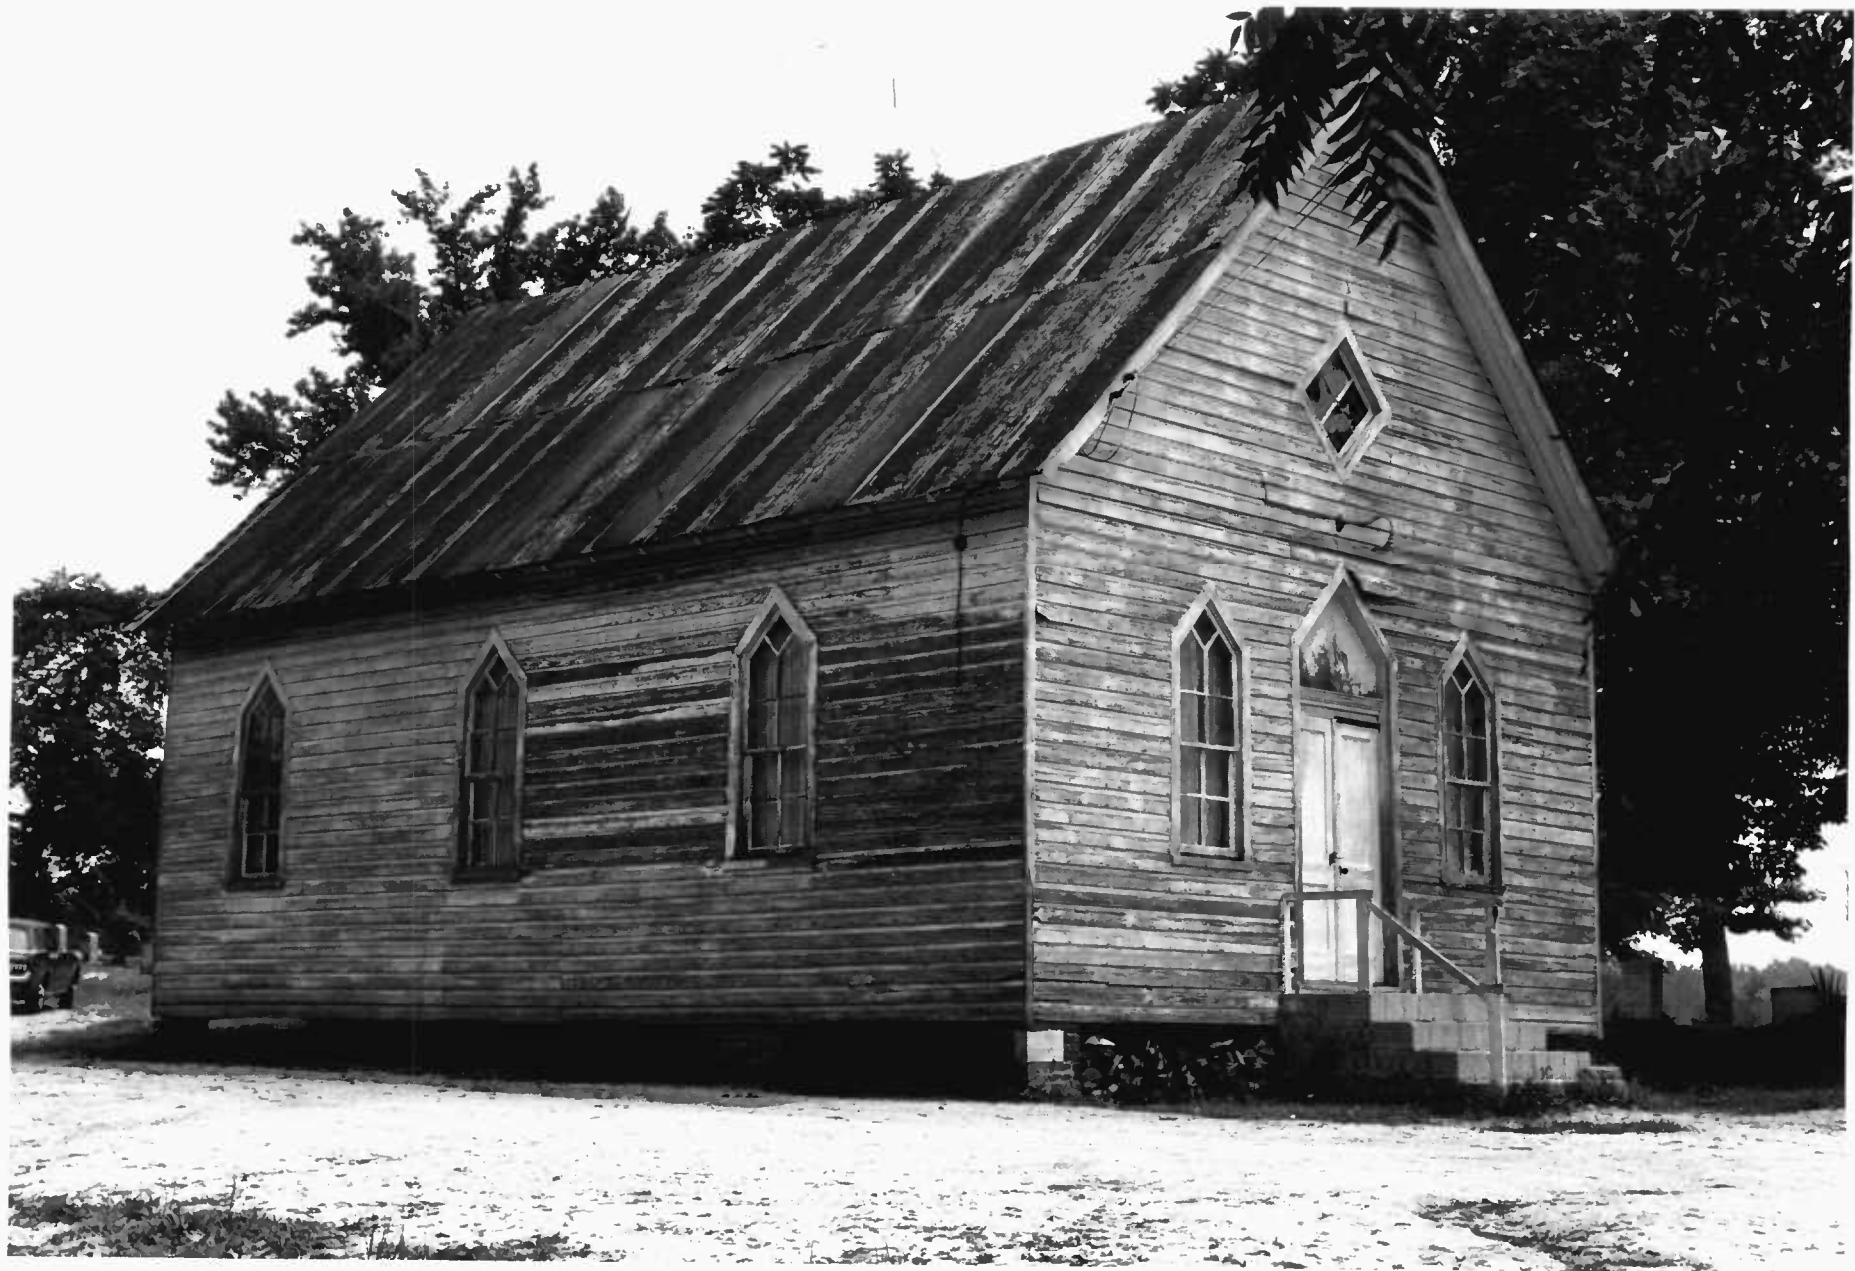
CT-20

4. NOTABLE FEATURES, HISTORICAL SIGNIFICANCE AND DESCRIPTION OPEN TO PUBLIC no <p>This building is the old St. Edmond's Church now replaced by a nondescript 1930's structure of brick. This old one is clapboarded with 3 windows on each side, a protruding 3 sided nave on the back and a door and 2 windows in the front with a diamond shaped window in the pediment.</p> <p>The door is pointed in the Gothic style. The windows are clear glass and also pointed in the Gothic style. A cornerstone in the base gives the date as 1893. This building is a good example of the many small Methodist Chapels constructed in the Victorian style throughout the countryside in the late 19th century.</p>

5. PHYSICAL CONDITION OF STRUCTURE Endangered Interior Exterior Deserted and falling into ruin.			
6. LOCATION MAP (Plan Optional)		7. PHOTOGRAPH	
8. PUBLISHED SOURCES (Author, Title, Pages) INTERVIEWS, RECORDS, PHOTOS, ETC.		9. NAME, ADDRESS AND TITLE OF RECORDER Paul A. Brinkman DATE OF RECORD July 17, 1967
